TECHNICAL REPORT GL-79-20

**INVESTIGATION OF BEACH SAND
TRAFFICABILITY ENHANCEMENT USING
SAND-GRID CONFINEMENT AND MEMBRANE
REINFORCEMENT CONCEPTS**

Report 2

SAND TEST SECTIONS 3 AND 4

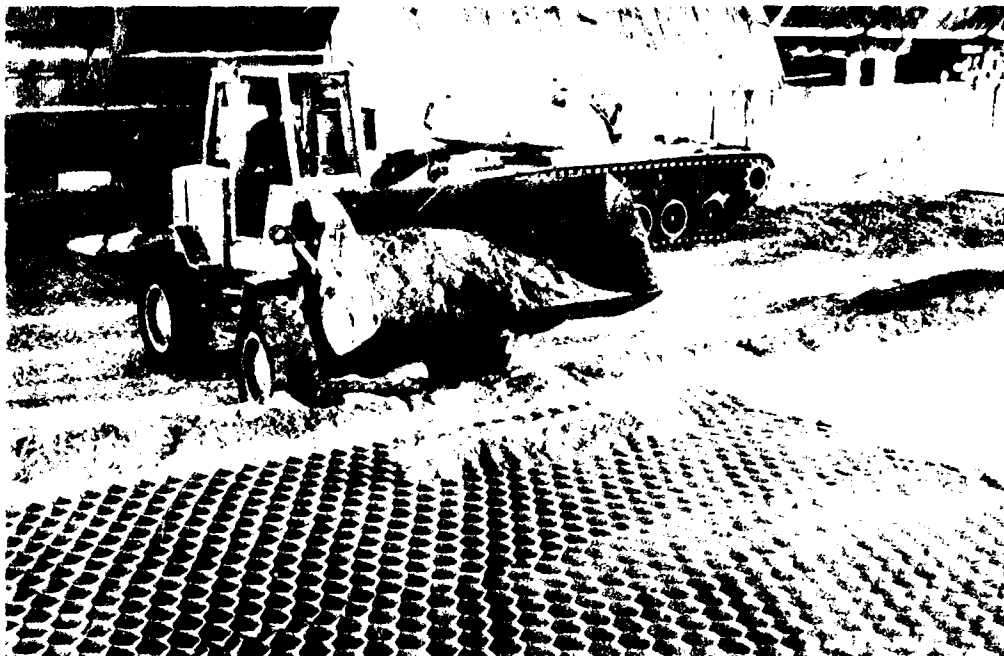
Photo 7. Front-end loader installing sand in grids,
test section 3

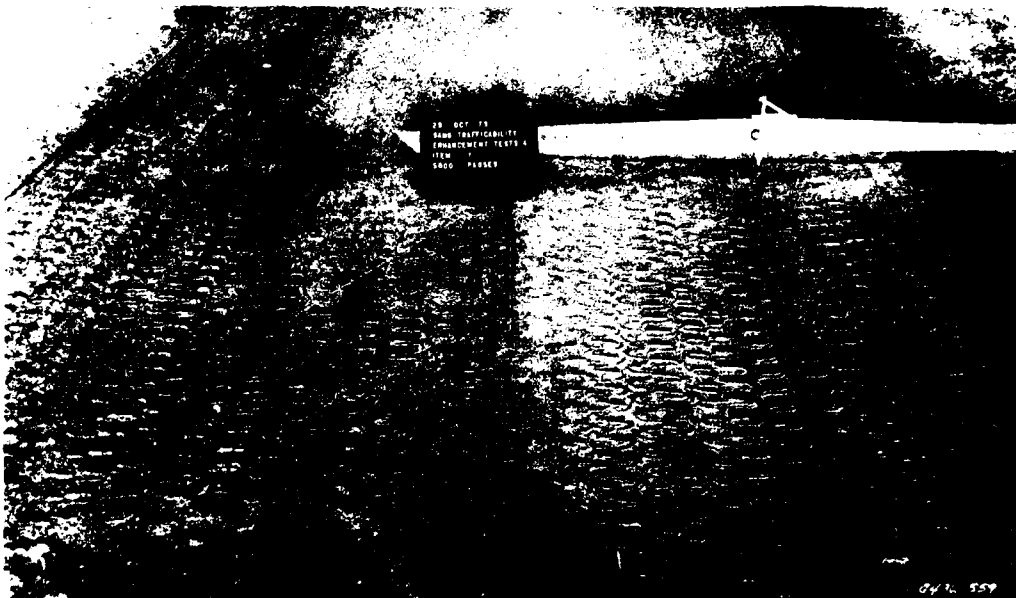
Photo 34. Item 1 after 5000 passes, test section 4

47. Item 1 (hexagonal grids, 6 in. thick). Performance of this marginal thickness item was very good. It indicated that the thickness of a sand-grid layer could be reduced when distributed traffic is used and the design life is moderate. Photo 33 shows the item in very good condition after 100 passes. Photo 34 shows the item still in very good
